# PAINT ADHESION TEST REPORT

Conducted by: Teknos GBI

### **DTS-Threshold Adhesion Tests**

To test the coating suitability of certain Teknos paints on Durodeen substrate supplied by DTS Thresholds.

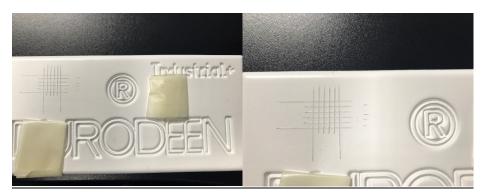
#### Sample A

1 coat of 2901 Anti Stain primer, sprayed at 150 microns.

2 Coats of Aqua Top 2600-22 Clean White Semi Matt sprayed between 150 - 175 microns and left to cure for 7 days.

Completed test shows the coating system achieved GT 0 according to the ISO 2409 classification table (see below).

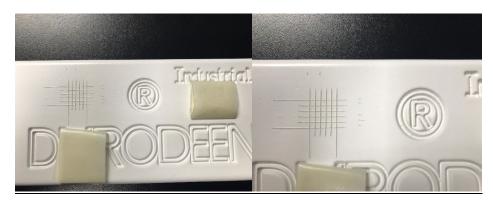
#### Sample B

1 coat of 5200 Knot Inhibiting Anti Stain primer, sprayed at 150 microns.

2 Coats of Aqua Top 2600-22 Clean White Semi Matt sprayed between 150 - 175 microns and left to cure for 7 days.

Completed test shows the coating system achieved GT 0 according to the ISO 2409 classification table (see below).

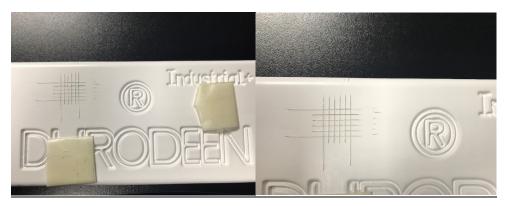
#### Sample C

$2\ \text{coats}$  of 5200 Knot Inhibiting Anti Stain primer, sprayed at 150 microns.

1 Coat of Aqua Top 2600-22 Clean White Semi Matt sprayed between 150 - 175 microns and left to cure for 7 days.

Completed test shows the coating system achieved GT 0 according to the ISO 2409 classification table (see below).
