Joinery Woodscrew Range

ZYTEC™ Woodscrews

**PN-EN ISO 9227
SALT SPRAY TEST**

TEST REPORT № LM-01278:00/2010

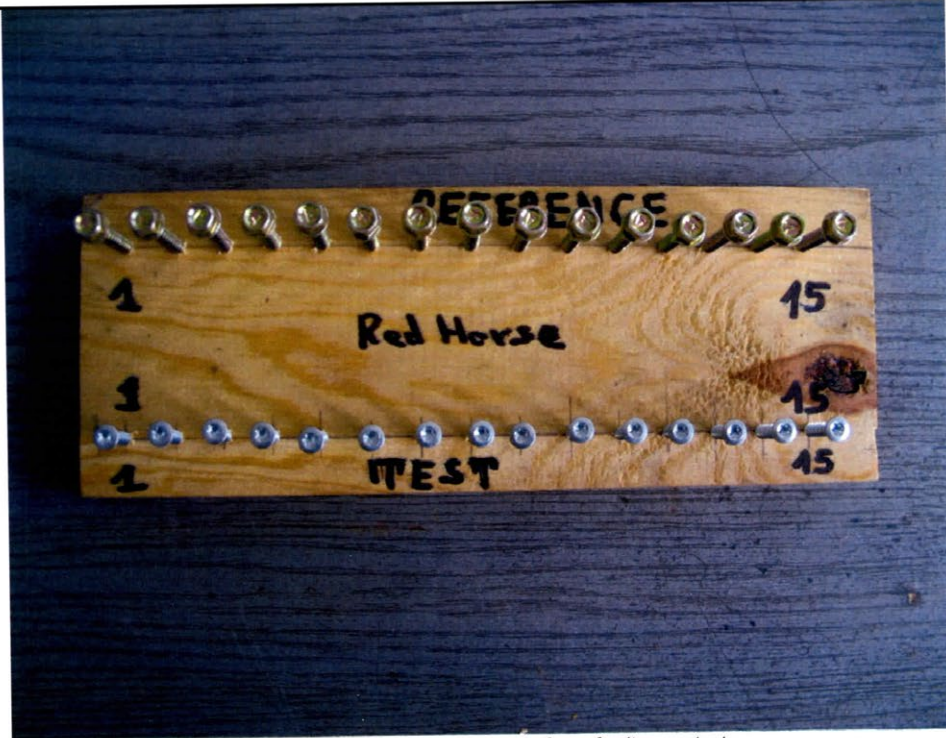
Phot. 1. The screws appearance before of salt spray test.

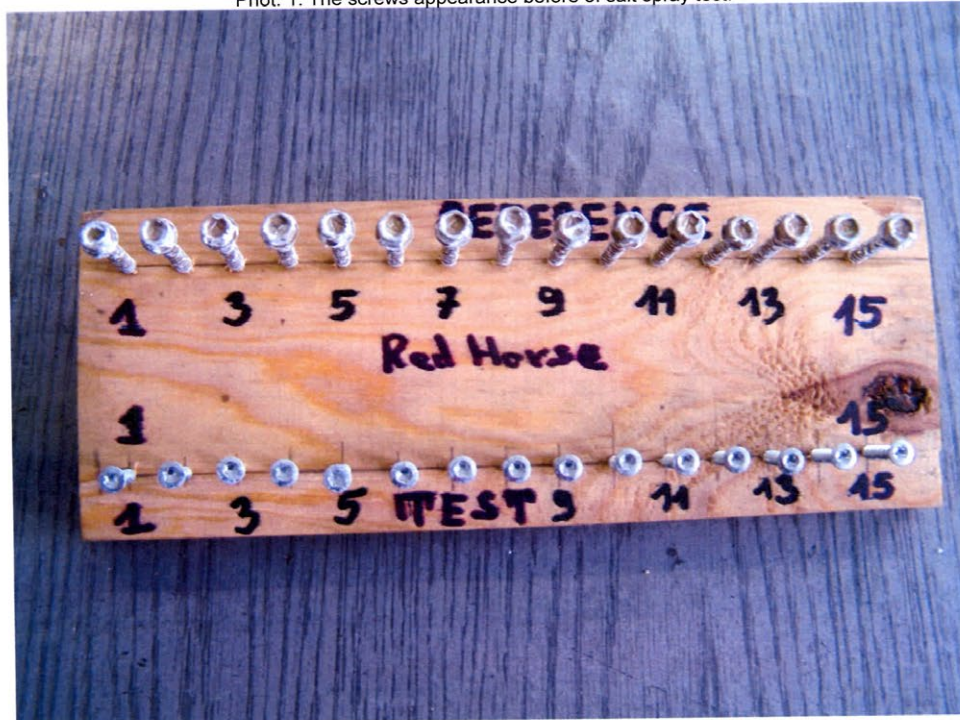
Phot.2. The screws appearance after 120 hours of salt spray test.

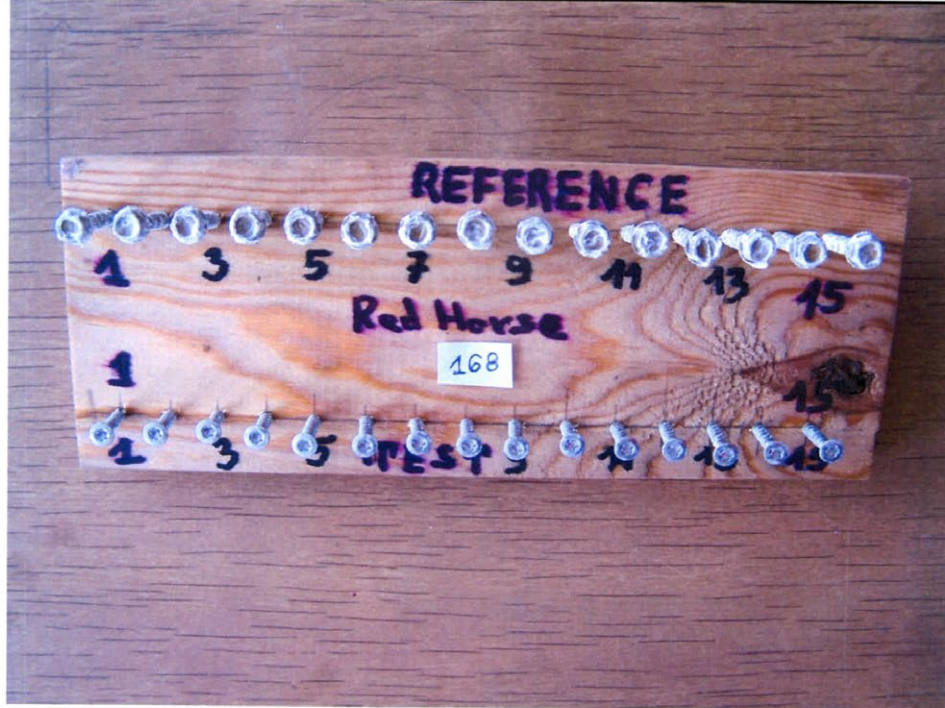
Phot.3. The screws appearance after 168 hours of salt spray test .

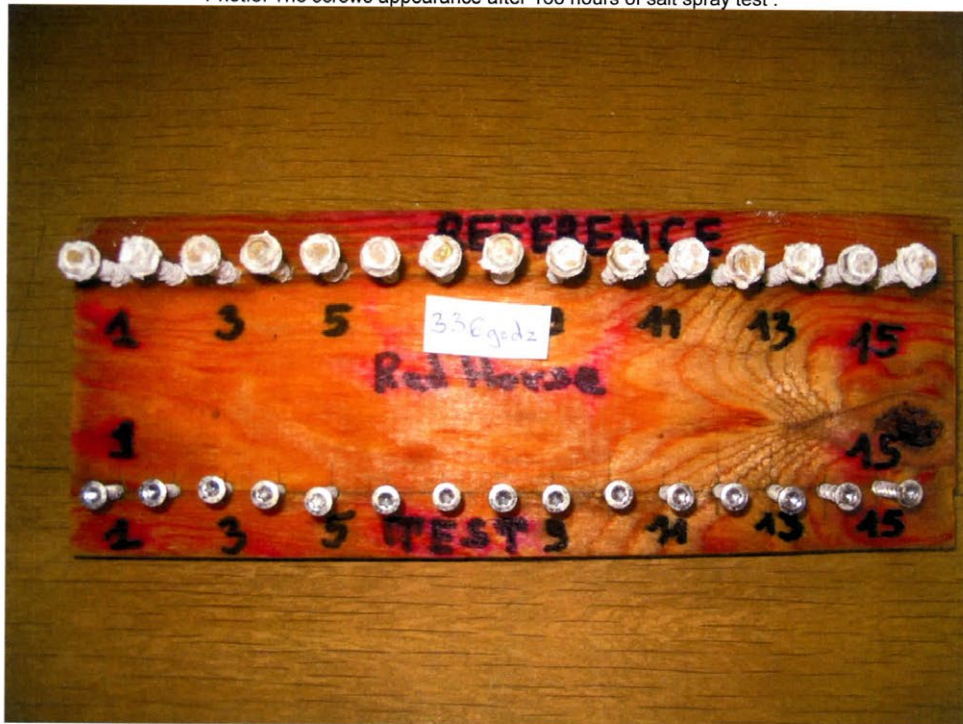
Phot.4. The screws appearance after 336 hours of salt spray test

<p>CLIENT: RED HORSE Niels Bohrs Vej 25-27, DK-8660 Skanderborg</p>	
<p>OBJECT: Protecting coatings ZYTEC™+ and Fe/Zn25c on the steel screws Taken to test on 02.04.2010 .at record No. LM-01278:00/2010 in accordance to quality management procedure No. 18 tested within a period from 08.04.2010 to 12.05.2010</p>	
<p>METHOD / PROCEDURE OF TEST: PN-EN ISO 9227: 2007 (resistance to salt spray).</p>	
<p>TEST RESULTS:</p>	
<p>Tested characteristics</p>	<p>Test result</p>
<p>I. Screws surface appearance after salt spray test</p>	
<p>I.1. Screws with ZYTEC™+</p>	
<p>I.1. 1. After 96 hours specimens 1 - 15</p>	<p>No corrosive changes on the screws surface</p>
<p>I.1.2. After 120 hours specimens 1 - 15</p>	<p>No corrosive changes on the screws surface</p>
<p>I.1.3. After 168 hours specimens 1 - 15</p>	<p>No corrosive changes on the screws surface</p>
<p>I.1.4. After 336 hours specimens 1 do 15</p>	<p>No corrosive changes on the screws surface</p>

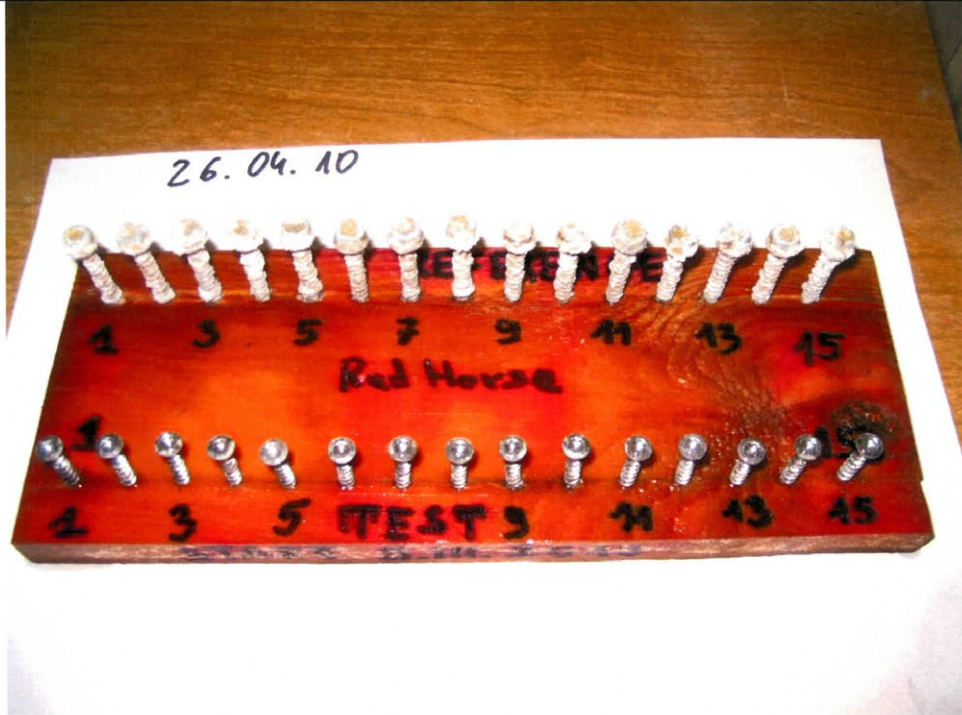
Phot.5. . The screws appearance after 456 hours of salt spray test

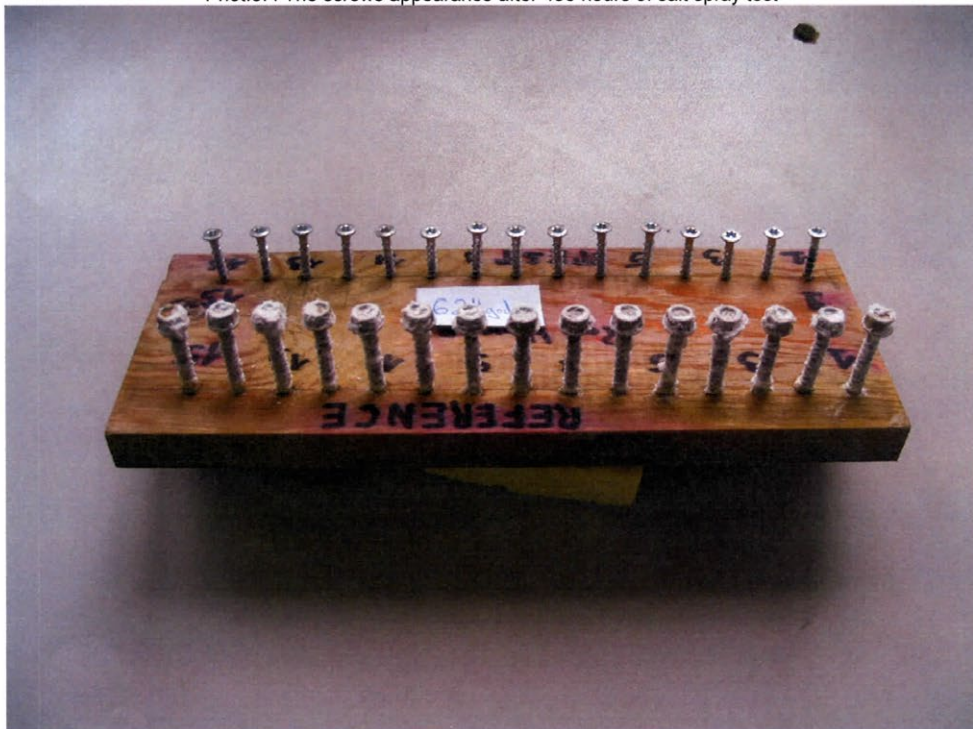
Phot.6. . The screws appearance after 624hours hours of salt spray test

<p>I.1.5. After 504 hours specimens 1 do 15</p>	<p>No corrosive changes on the screws surface</p>
<p>I.1.6. After 624 hours</p>	<p>The screw No 1: screw-thread – change in colour. On each thread edges little white tarnish is visible.</p>

I.2.4. After 336 hours	<p>The increase in thickness of white tarnish on the surfaces of all screw-threads and screw-heads.</p>	
I.2.5. After 504 hours	<p>The increase in thickness of white tarnish on the surfaces of all screw-threads and screw-heads.</p>	
I.2.6. After 624 hours	<p>The screw No. 15 : visible red- rust on the ~ 50% of screw –head and ~ 1% screw-thread surfaces. The thick white tarnish is visible on all screws.</p>	
I.2.7. After 696 hours	<p>The screws No: 4 & 15, the red- rust is visible.</p>	
I.2.8. After 816 godz.	<p>The thick white tarnish is visible on all screws surfaces (No. 1÷15). The screw No: 15: the red- rust is visible on the ~80% of screw surface.</p>

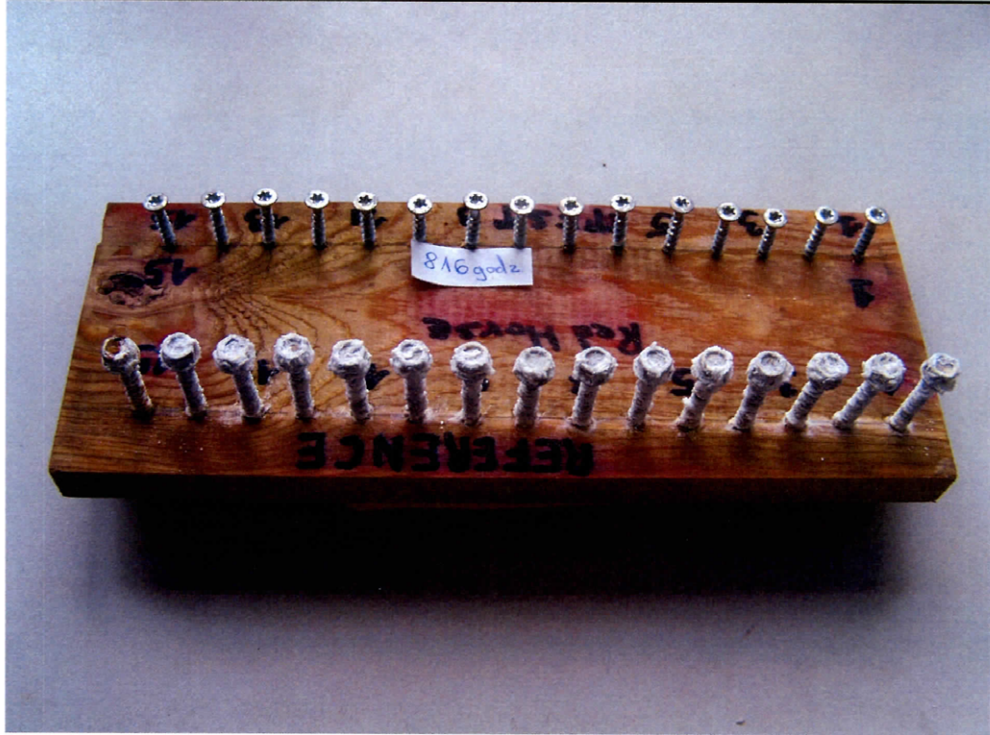
Phot.7. . The screws appearance after 816 hours hours of salt spray test		
Responsible for the test: eng. Wojciech Piwowarczyk
